# Site Location and Photographs

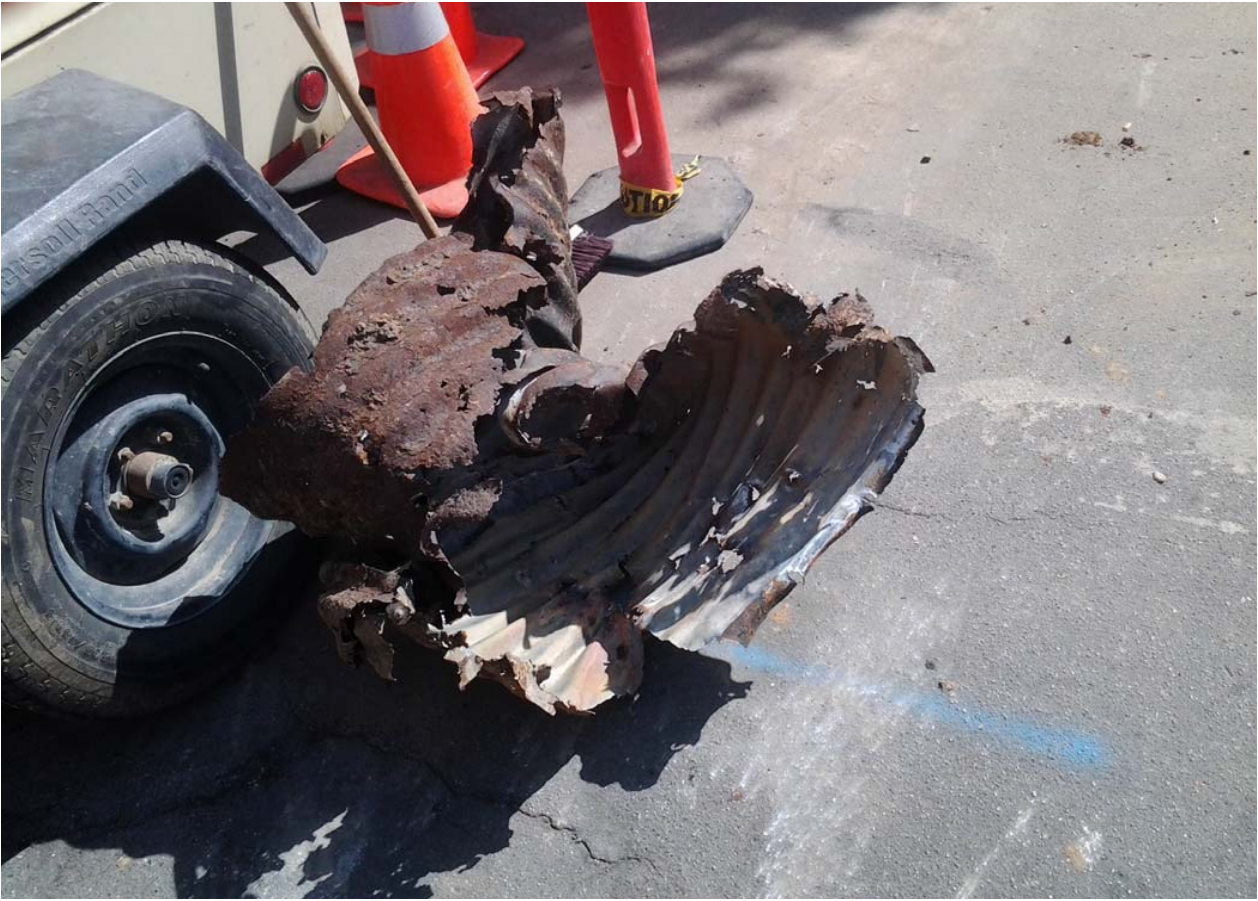
Removed Section of Rusted Corrugated Metal

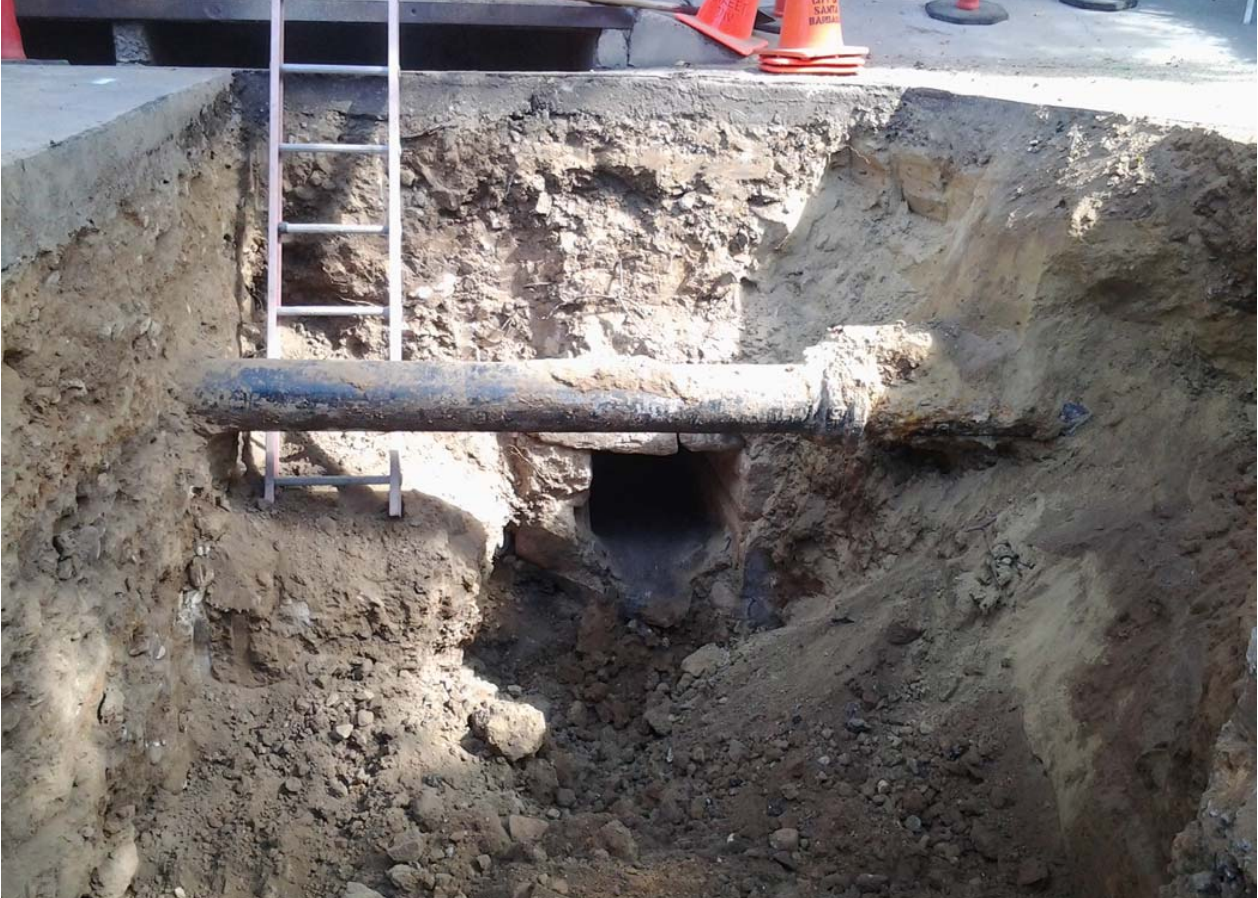
Excavation Prior to Storm Drain Replacement (Looking Upstream)
