Duke McPherson, Arborist

May 16, 2010

Regarding: Coast Live Oak tree protection issues, 1402 Grand Avenue, Santa Barbara, California.

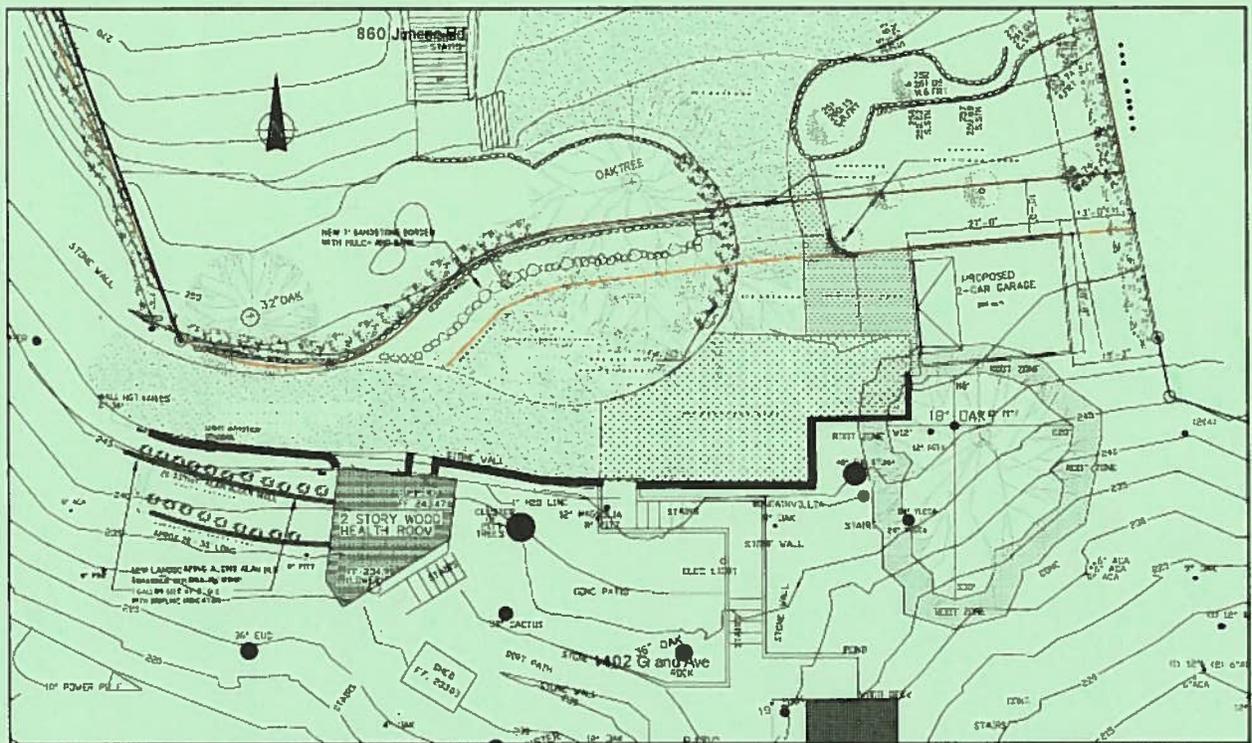
EXHIBIT D

The tree is located on the upper edge of a steep slope above and to the northeast of the main residence building (see the accompanying plan section). It has an 18" trunk diameter at 4.5' up from the soil level. At present it appears to be in good health though, being situated in a fast draining soil medium, is subject to fluctuation depending on seasonal rainfall totals.

The Critical Root Zone (CRZ) of the tree is represented by the area within the dripline plus 5', is shown on the attached site plan section along with the outline of the proposed garage. The configuration of the garage outline overlaps the CRZ for a maximum of 3' along an 18' section.

I conclude that the area intruded upon by the garage foundation excavation is of such a small fraction of the total CRZ that the tree's health will not be affected.

The subject oak (18" trunk diameter) is located to the right of the plan section. Its Critical Root Zone is the area from the trunk to the outer edge of the darkened five foot zone adjoining the tree's dripline.
