**HISTORIC LANDMARKS COMMISSION
LANDMARK DESIGNATION
STAFF REPORT**

**Saint Anthony's Seminary Complex and Grounds
2300 Garden Street
APN 025-140-024
September 12, 2012**

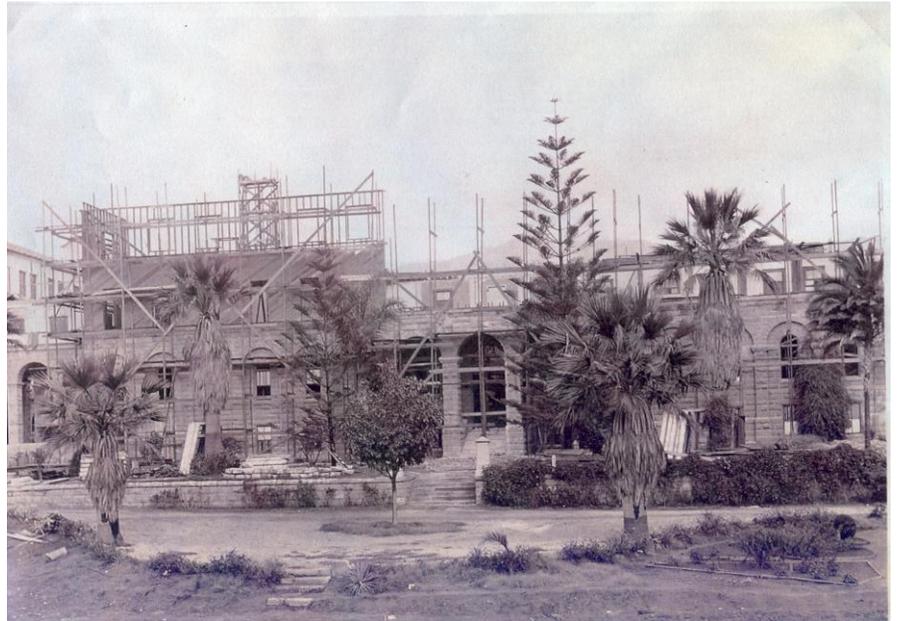
1925 reconstruction of Main Building after earthquake.
Courtesy Mission Archives

The earthquake on June 29, 1925, severely damaged the Mission and St. Anthony's Main building. Montgomery was hired to oversee the restoration of both buildings. Montgomery repaired the stonework of the first and second floors of the Main building and replaced the original, stone, top-two stories with frame and stucco over a continuous reinforced sill course. The new, top-two floors were designed in the Spanish Colonial Revival style with Spanish Renaissance ornamentation. Montgomery also renovated the first floor entrance with new stone steps, landing, iron railings, door with lunette, and lantern light fixture.

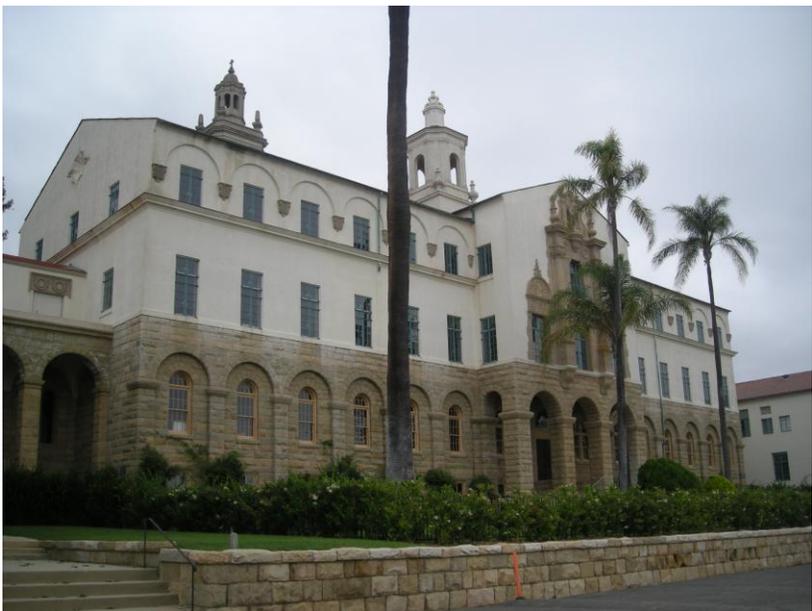
*Main Building of St. Anthony's Seminary Main Building featuring Romanesque lower floors and Spanish Colonial Revival Upper floors.
July 9, 2012.*

Constructed in 1899-1901 and renovated in 1926, the main building is a rectangular, side-gabled, four-story building around which the wings are arranged. The building embodies elements of the Romanesque style with rough ashlar (rusticated) sandstone on the lower two floors, which were part of the original 1899 building. The sandstone was quarried on site and in the nearby Mission Canyon under the supervision of chief stonemason Antonio Leyva (1862-1936). The architectural style was based on the early medieval church buildings of various parts of Europe and common in the United States in the mid-nineteenth century. Character defining Romanesque features of the Main building are the rough face, squared stone, masonry walls and rounded arches over the windows and entrance topping massive piers and pilasters. The building has a central

sandstone entry pavilion with three, two-story high Romanesque, round arches that dominate the south façade and is mirrored in the series of two-story blind arches set between pilasters that are articulated with capitals and bases that flank the pavilion and form the remainder of the wall surface on the south façade. Within the blind arches are wood frame windows with heavy sandstone lintels and sills. The first floor has simple, two-over-two, wood, rectangular windows. The second floor windows have eight-over-eight lights, heavy rounded muntins and arched transoms set within round arched openings which mimic the larger stone arches.

Added after the 1925 earthquake, the top two floors of the Main building are stucco-clad in the Spanish Colonial Revival style. The third story is articulated by a large cornice above which rises the shorter fourth story whose simple casement windows are surrounded by corbels supported on engaged capitals. Both floors have metal-sash, multi-paned casement windows with transoms, arranged symmetrically with those below. The gable ends of the building, difficult to see because of the additions, are defined by large quatrefoil vents and paired eight-paned casement windows with transoms.

The dominant front gable has Classical Spanish Renaissance detailing rising two stories above the Roman arches at the entry. This cast stone detailing includes: paired columns with both smooth and fluted surfaces; giant finials; four windows with richly carved lintels; and, at the apex of the gable is a niche holding a statue of St. Anthony. Centered over the front-facing gable above the front entrance is an ornate, red-tile roofed, octagonal cupola, with finials at the four corners, is topped by an octagonal lantern with four large scrolls as its cap.

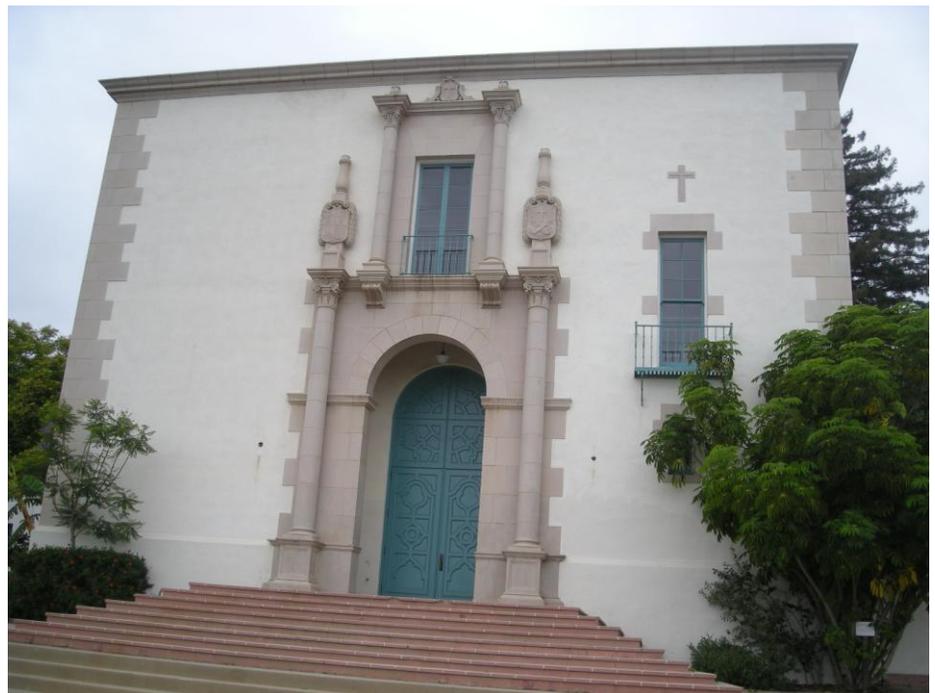
*West Wing added in 1923.
July 9, 2012.*

This two-story, rectangular, stucco-clad building, with a red-tile hipped roof, is oriented in line with the Main building. Designed in the Spanish Colonial Revival style with Classical decorative details that include: cast stone quoins, cast stone floral ornamentation on the enclosed staircase on the north elevation, and a cast stone, scored door surround at the south entrance. The Spanish Colonial Revival style details include the red-tile hipped roof, shed-roof arcade on the east elevation, the arched entrance with coffered ceiling which shelters a huge paneled double door, and the Juliet balcony supported on scrolled brackets on the front façade.

Connecting the West Wing to the Main building is a two-story arcade of stucco and sandstone arches and interior vaulted arches with cast concrete lintels decorated with garland and shield motifs is found above the second floor windows.

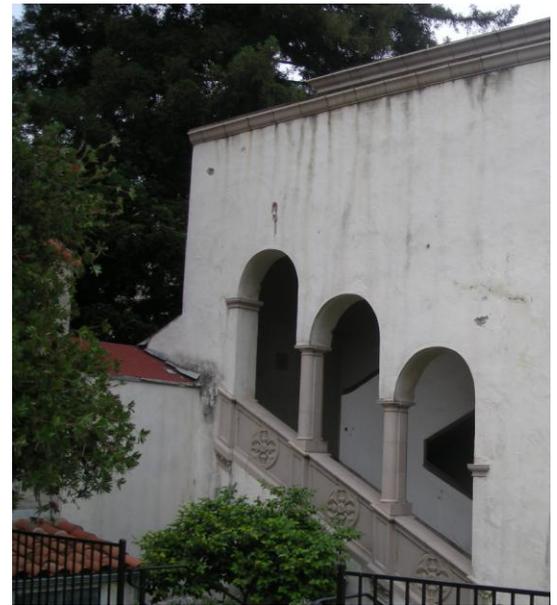
*Staircase of West Wing with Classical cast stone floral ornamentation.
July 9, 2012.*

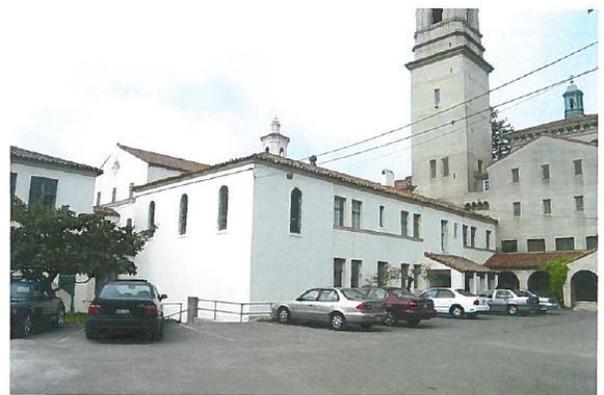
*Service Wing, showing arched windows of small chapel, facing southwest.
2009, Courtesy of A. C. Cole, Historic Structure Report.*

The rectangular building with a red-tile hipped roof was designed in the Spanish Colonial Revival style. The stucco walls are characterized by recessed multi-paned windows and wood doors. There are arched stained glass windows on the upper floor of the north and east elevations where a small chapel is located. The red-tiled arcade on the north elevation and the large cornice separate the top floor from those below. It is connected to the Main building by a second floor arcade, which features a cast-stone decorative lintel over a wide entry way into the service courtyard. It is linked to the Refectory building by a red-tiled roofed, stucco clad arcade with arched multi-paned windows.

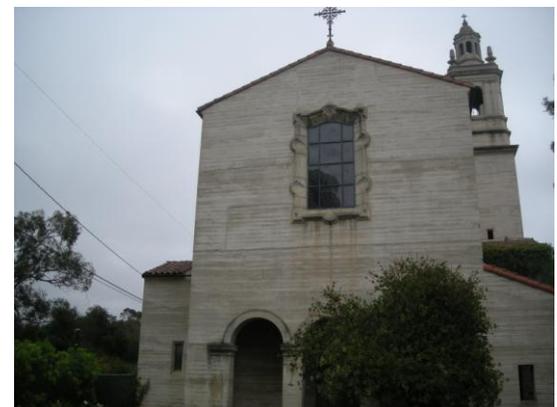
*Front Elevation of St. Anthony's Romanesque Chapel.
July 9, 2012.*

Built of poured-in-place concrete, the Romanesque chapel has a central gable-roofed nave bisected by a series of red-tile, gable-roofed wings. A large square cupola, with oculus windows, ornate brackets and frieze rises at the crossing of the nave and transept, and is topped by a small pressed metal lantern.

The front, west elevation has three Roman arches, mimicking those on the Main building, topped by a large stained glass window in the center of the gable, surrounded with cast stone ornamentation. A similar large stained glass window lights the north elevation. The square seven-story bell tower rises to an octagonal belfry and cupola. The Classical details at the belfry and cupola include cornice bands, a frieze with swag decoration, Doric pilasters, engaged columns, and four corner finials.

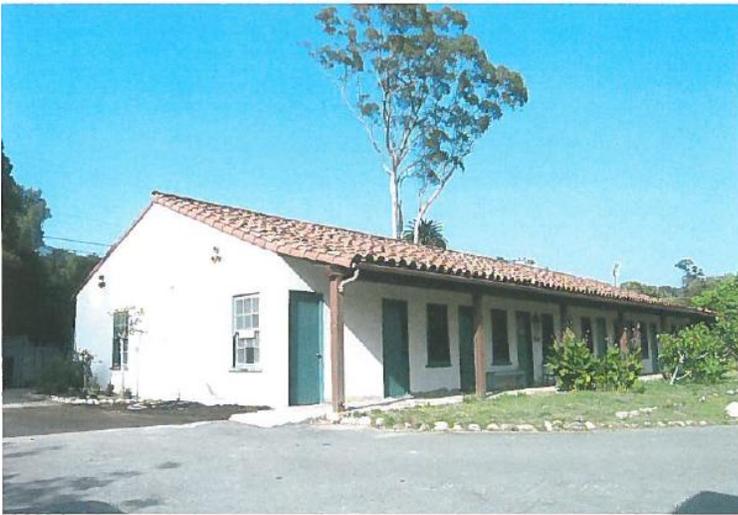
*Shop Building,
2009, Courtesy of A. C. Cole, Historic
Structure Report.*

A small rectangular shop/garage building of wood-frame clad in stucco lies to the east of the main complex. The side-gabled red-tile roof extends to form a shed roof porch supported on wood posts, which shelters the nine, wood plank entrances to the small rooms on the south side. The flooring of this covered porch is sandstone. At the rear are four large shops. Six-over-six double hung windows in wood surrounds light the interior. The shop presence contributes to the spatial relationship of the whole complex.

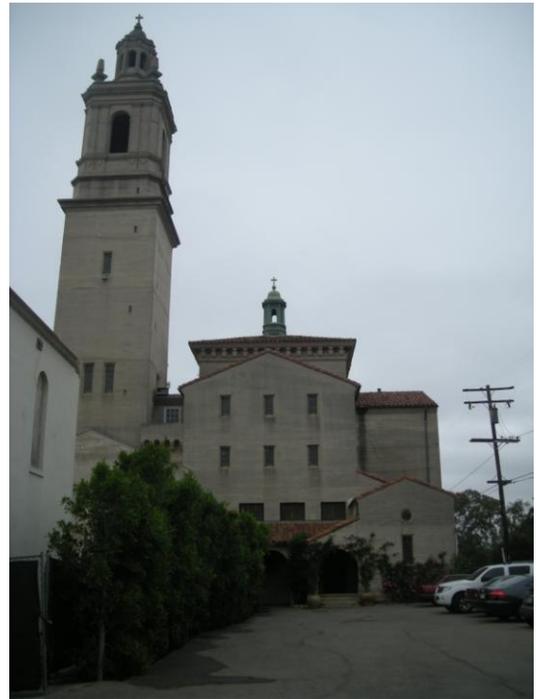
*Chapel and Campanile added in 1926,
July 9, 2012.*

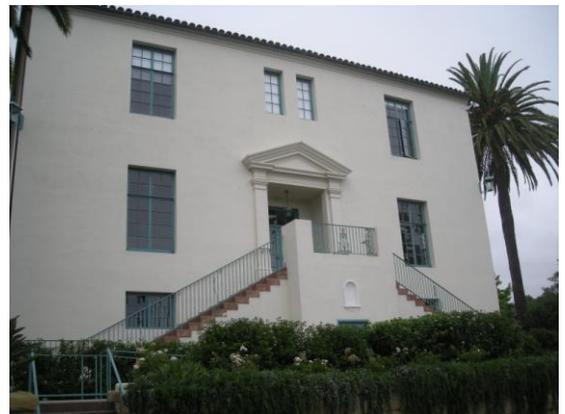
*Refectory with Classical pediment over the
doorway.
July 9, 2012.*

The Refectory on the east side of the Main building is a Spanish Colonial Revival style, three-story, rectangular building with stucco walls and a shallow-pitched, red-tiled, hipped roof. The divided staircase leads to a doorway with a Classical pediment flanked by Doric pilasters. The east entrance is sheltered by a porch with a

red-tile hipped roof supported on square columns with Doric capitals and bases. The facades are characterized by wood, deeply recessed, multi-paned windows with transoms.

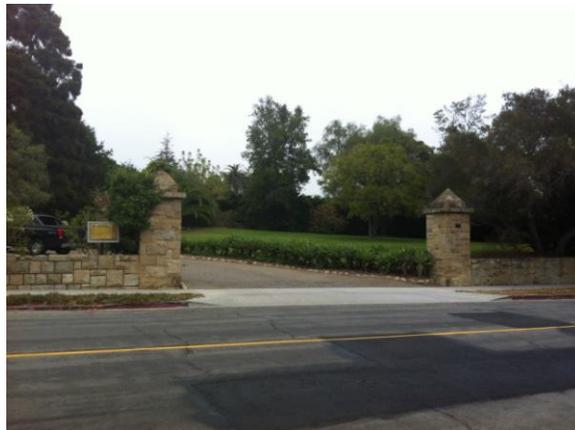
*Sandstone pillars flanking the entrance to St. Anthony's Seminary
July 9, 2012.*

By 1928, large sandstone pillars flanked the entrance to St. Anthony's Seminary interrupting a rough faced ashlar sandstone wall on Garden Street that rose to a high aggregate wall covered with a skim coat of stucco scored to look like stone. The site sloped from north to south, necessitating a series of stepped sandstone retaining walls.

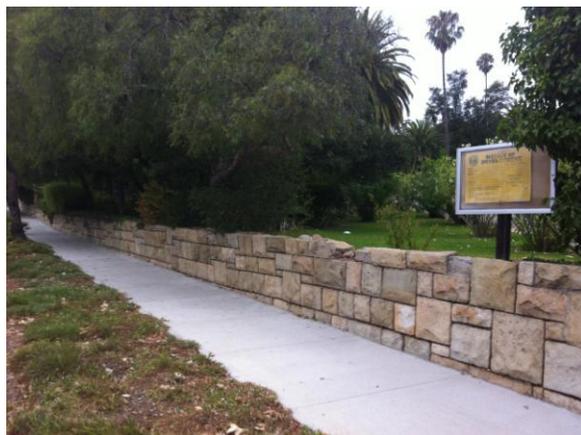
*Detail of Sandstone ashlar wall along Garden Street
July 9, 2012.*

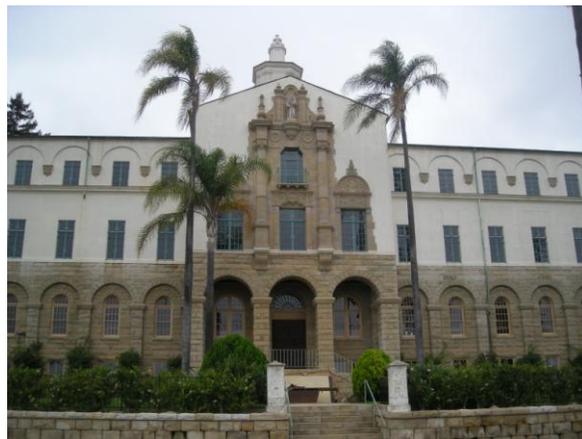
*View of palms flanking front entrance of Main Building and retaining wall in front of Main Building
July 9, 2012.*
